**The Dead Sea Earthquake mb 5.1 of February 11, 2004**  
*A Preliminary Report*

**An-Najah National University  
Earth Sciences and Seismic Engineering Center (ESSEC),  
Nablus, P.O. Box 707, Palestine**

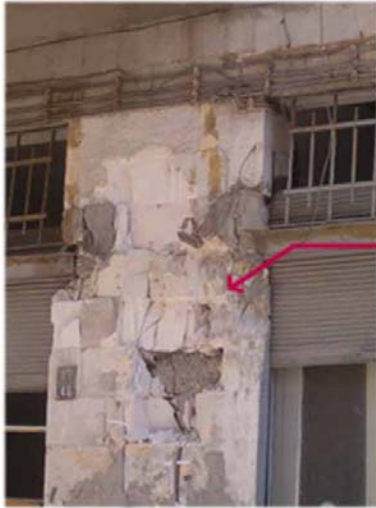
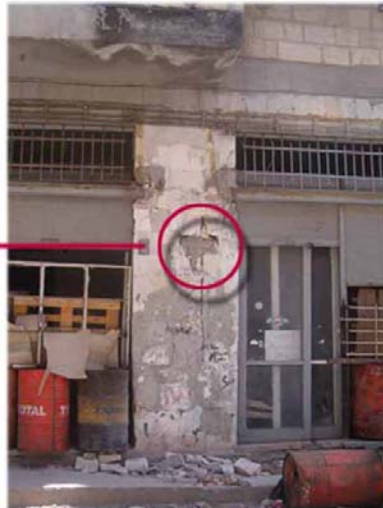
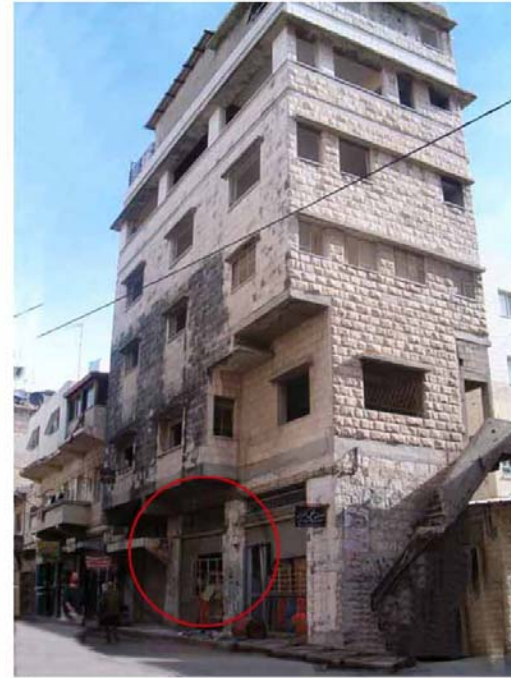
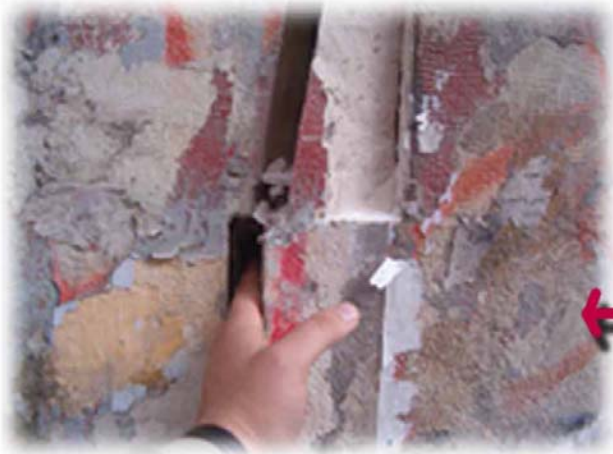
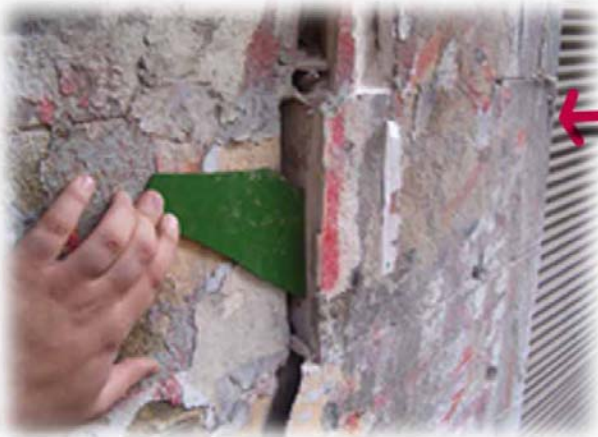
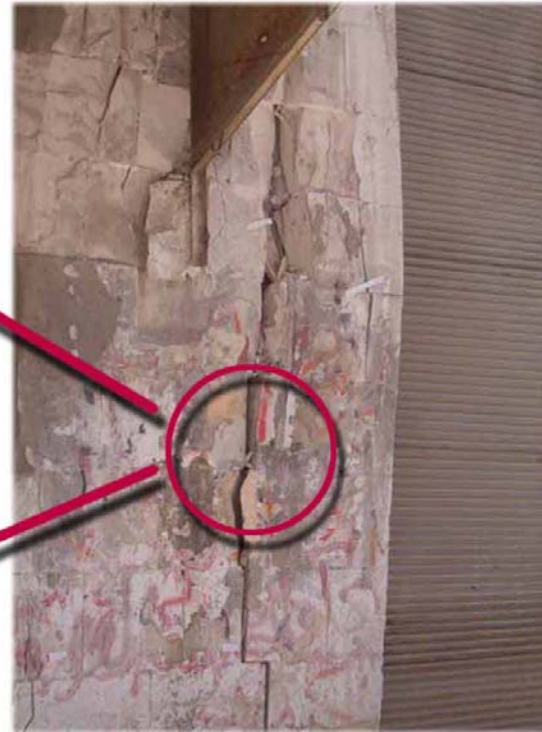
fig. 1  
Crack Patterns, Crushing  
and Large permanent  
deformation in the  
Masonry Pillars.  
see more details page no. ( 4/8 )  
page 3/ 8

## Five Storey Masonry Building- NABLUS City

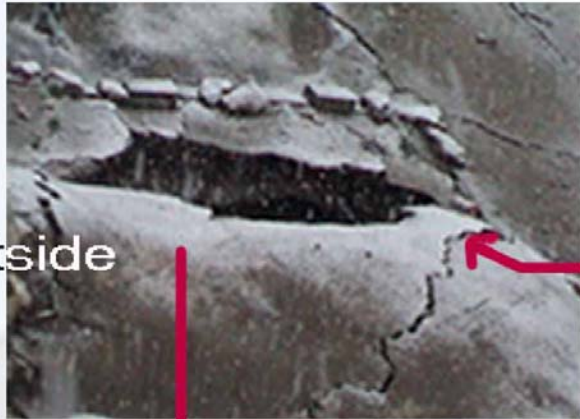
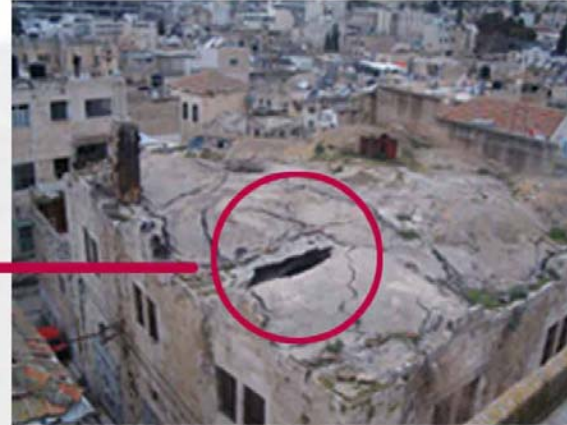
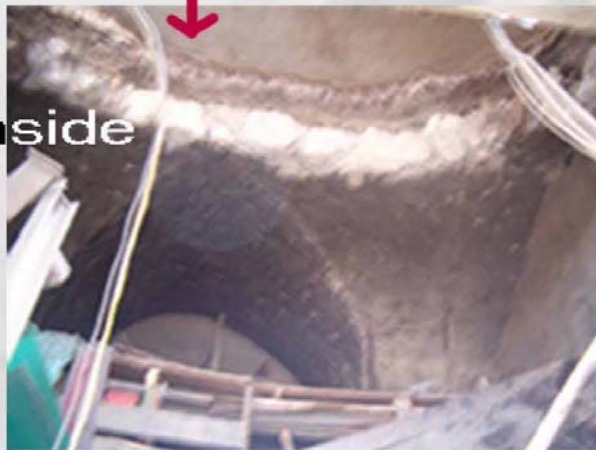
fig. 2

A flat vault's collapse

Old Masonry Building

Location: Old town of NABLUS city

Structural System: Cross Vault's

Use: Soap Factory

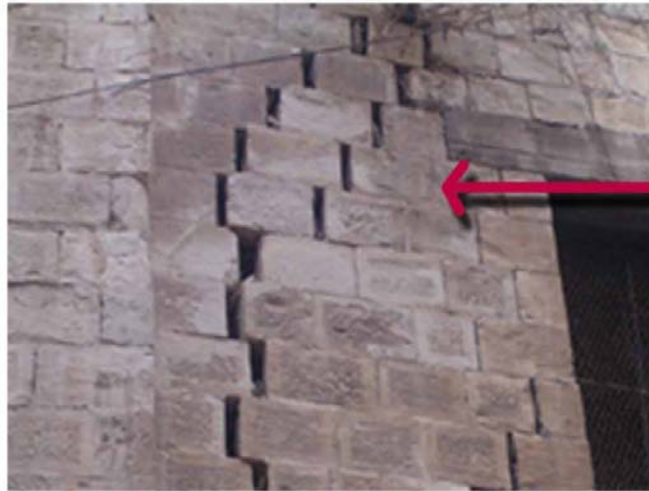
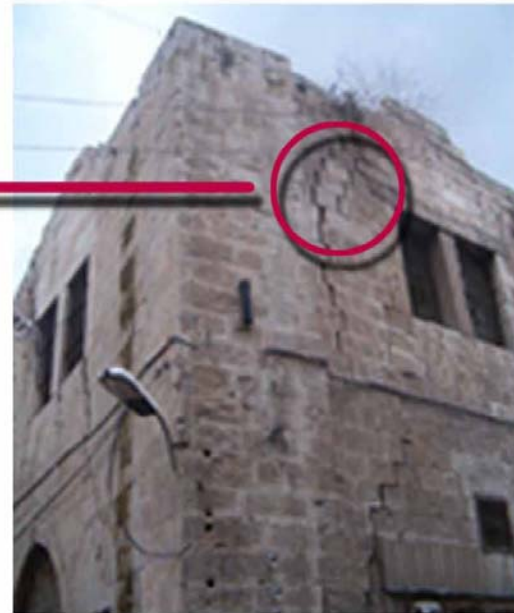
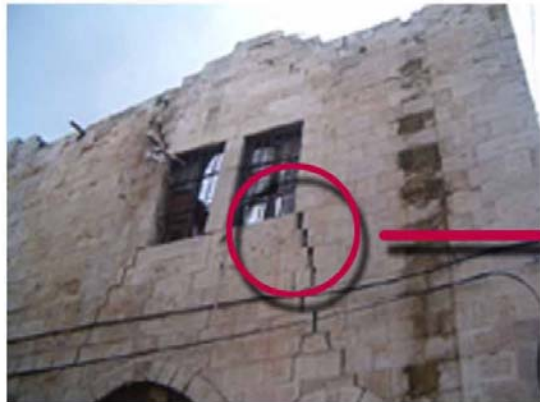
Corner Detachment of Building

Old  
Masonry  
Building

Location: Old town of NABLUS city  
Structural System: Cross Vault's  
Use: Soap Factory

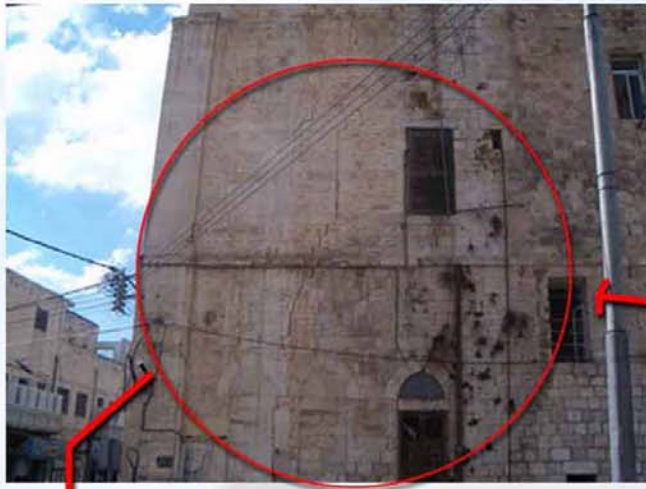
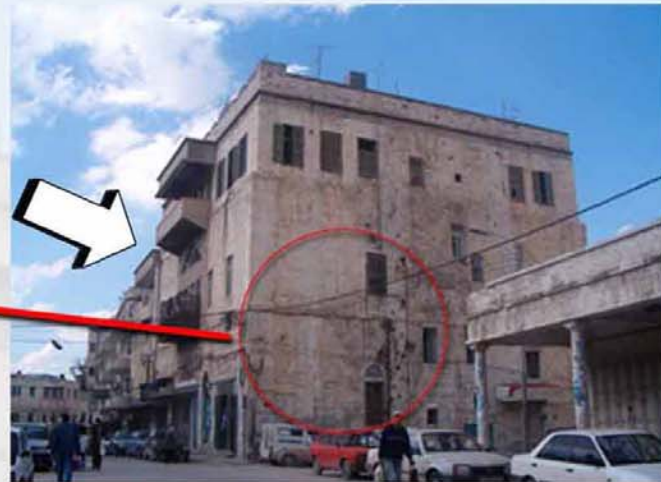
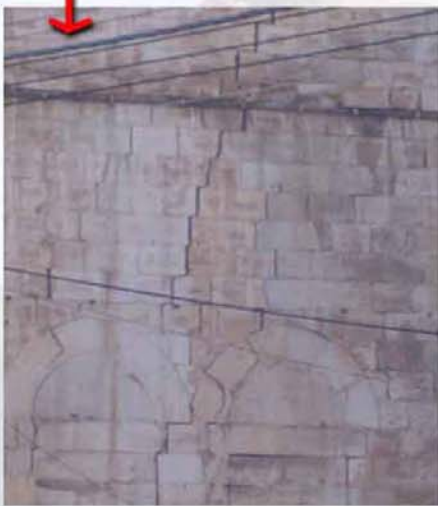
fig.3  
Old Masonry  
Building  
NABLUS City

Crack patterns
